## **PARTS BREAKDOWN**

PART NUMBER 0002076716

1119

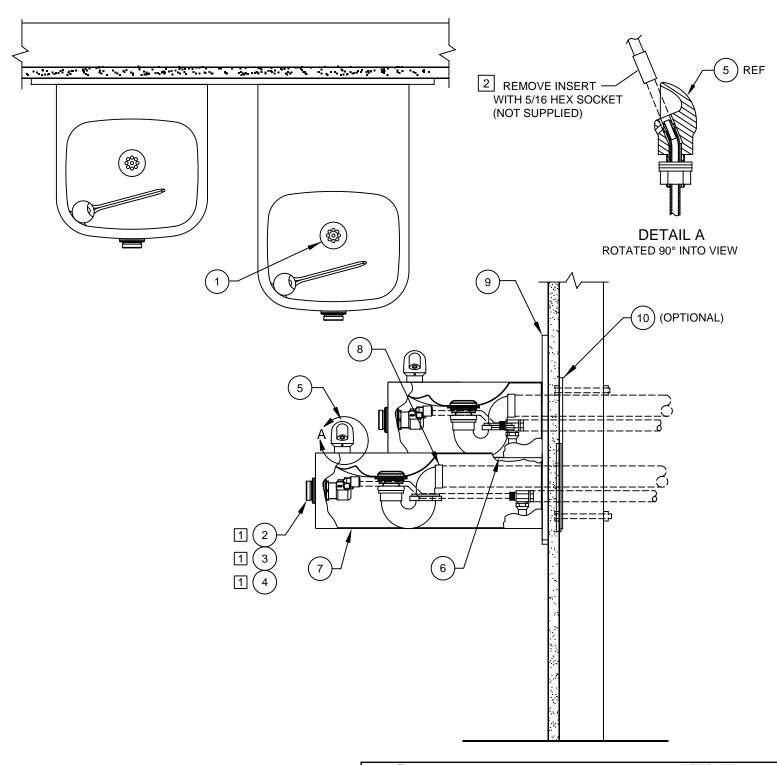
- 1 5874PBF (ITEM 2) INCLUDES VRK5874 CARTRIDGE ASSEMBLY (ITEM 3) AND PBA6 FLANGED PUSH BUTTON (ITEM 4).
- 2 ENSURE TUBE IS DISCONNECTED FROM PUSH BUTTON VALVE BODY PRIOR TO REMOVAL. APPLY ONE DROP OF LOCTITE 222MS TO NOZZLE THREADS PRIOR TO FASTENING BACK ONTO BUBBLER HEAD. RE-ATTACH TUBE TO VALVE.

ITEM	DESCRIPTION	1119
1	STRAINER, WASTE ASSY	6462
2	BUTTON, PUSH, FLANGED, PCP W/ VALVE	5874PBF
3	VALVE REPAIR KIT	VRK5874
4	PUSH BUTTON ASSY	PBA6
5	BUBBLER HEAD ASSY, PCP	5703M
6	PLATE, BOTTOM	PBM1105
7	PLATE, BOTTOM	PBM1109
8	TRAP	0005982900
9	BACK PANEL	0004023580
10	PLATE, MOUNTING	6700.4
