ASSEMBLED 5874PB (RECESSED MOUNT APPLICATION)

INSTALLATION INSTRUCTIONS FOR 5874PB.

> PART NUMBER 0002077650.D

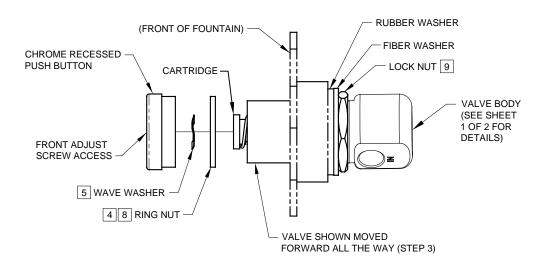
- 1) FOLLOW INSTRUCTIONS CAREFULLY ON O&M MANUAL (PAGE 2 OF 6) WHEN REMOVING OLD VALVE. NOTE: SEE PARTS BREAKDOWN (PAGE 4 OF 6) FOR ADDITIONAL NOTES.
- 2) VERIFY THAT LOCK NUT, FIBER WASHER, AND RUBBER WASHERS ARE POSITIONED TOWARD BOTTOM END OF THREADS ON NEW VALVE BODY.
- 3) INSERT VALVE INTO BRACKET FROM INSIDE, AND PUSH ALL THE WAY FORWARD (SEE ILLUSTRATION ABOVE).
- 4 THREAD RING NUT ONTO VALVE BODY, AS FAR IN AS POSSIBLE, TOWARD FRONT OF FOUNTAIN.

- 9 PUSH VALVE BACK TOWARD THE INSIDE OF BRACKET AND TIGHTEN LOCKNUT (SEE ILLUSTRATION ABOVE).
- 10) TIGHTEN PUSH BUTTON ASSEMBLY USING UNIVERSAL SPANNER WRENCH PROVIDED.
