model 5874PBF

Fountain valve

INSTALLATION INSTRUCTIONS FOR 5874PBF.

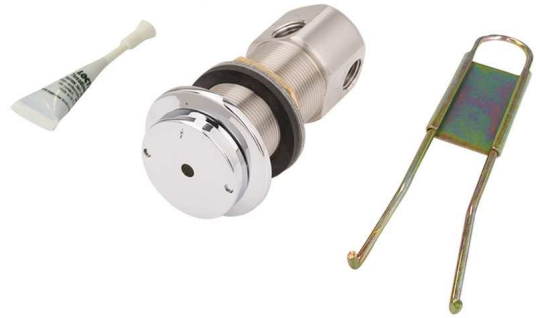
With its patented push-button design which allows for front access stream adjustment as well as cartridge and strainer access, this valve offers the ultimate in ease of maintenance.

Model 5874PBF fountain valve is a patented lead-free stainless steel push button valve shall include a polished chrome-plated brass flush mounted style push button assembly with front stream adjustment and cartridge serviceability, automatic pressure regulation from 30 - 90 psi (2.1 - 6.2 bar) and has a 1/4" NPT inlet and outlet.

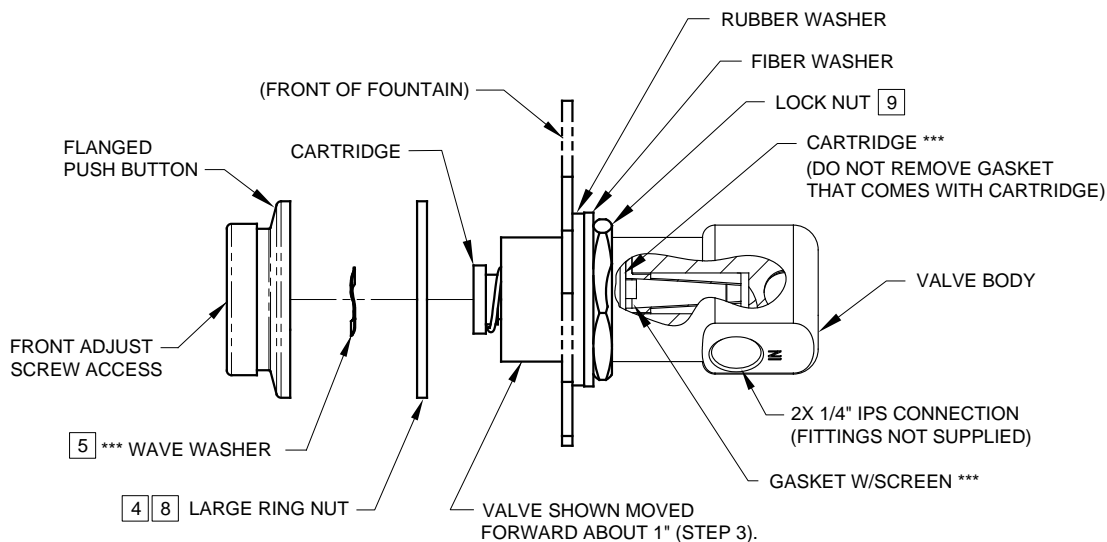
ASSEMBLED 5874PBF
(FLUSH MOUNT APPLICATION)

*** MODEL VRK5874 & VRK5874HF- VALVE REPAIR KITS INCLUDE THESE ITEMS

- 2) VERIFY THAT LOCK NUT, FIBER, AND RUBBER WASHERS ARE POSITIONED SLIGHTLY PAST MIDWAY OF THREADS ON NEW VALVE BODY.
- 3) INSERT VALVE INTO BRACKET FROM INSIDE AND PUSH FORWARD ABOUT 1".

- 4] THREAD LARGE RING NUT ONTO VALVE BODY, APPROXIMATELY 1" INTO VALVE.
- 5] PLACE WAVE WASHER INSIDE OF FLANGED PUSH BUTTON ASSEMBLY (**MUST BE IN PLACE**).

- **7) THREAD FLANGED PUSH BUTTON ASSEMBLY ON VALVE UNTIL WAVE WASHER MAKES SLIGHT CONTACT WITH STEM OF CARTRIDGE. **CAUTION: DO NOT HAND-TIGHTEN.**
- 8] UNTHREAD RING NUT FORWARD UNTIL IT STOPS FLUSH WITH PUSH BUTTON ASSEMBLY.

- 9] PUSH VALVE BACK TOWARD THE INSIDE OF BRACKET AND TIGHTEN LOCKNUT (SEE ILLUSTRATION ABOVE).
- 10) TIGHTEN PUSH BUTTON ASSEMBLY USING UNIVERSAL SPANNER WRENCH PROVIDED.

** OVERTIGHTENING WILL PRE-ACTUATE VALVE AND CAUSE WEEPAGE, WHILE NOT ENOUGH CONTACT BETWEEN WAVE WASHER AND STEM CAN CAUSE A LOW FLOW CONDITION.

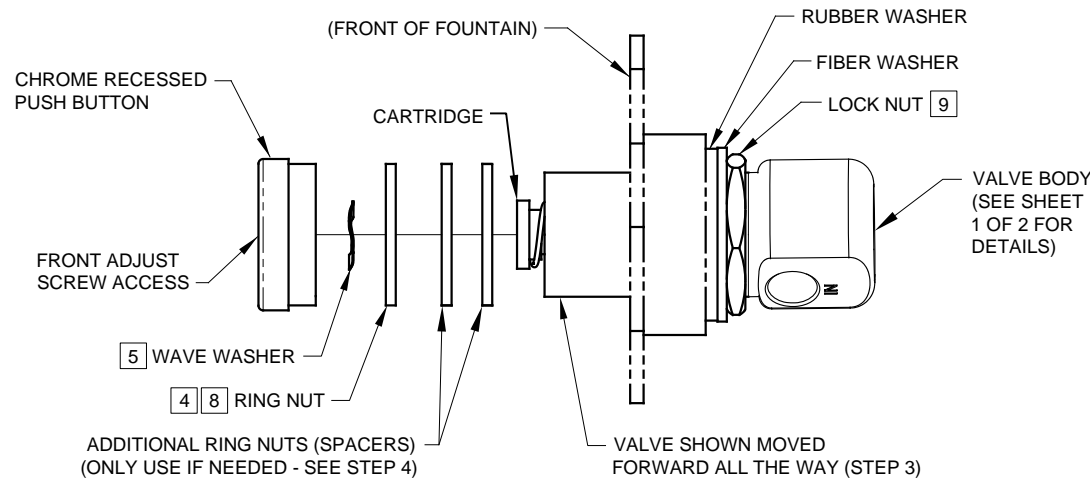
ASSEMBLED 5874PB
(RECESSED MOUNT APPLICATION)

- 2) VERIFY THAT LOCK NUT, FIBER WASHER, AND RUBBER WASHERS ARE POSITIONED TOWARD BOTTOM END OF THREADS ON NEW VALVE BODY.
 - 3) INSERT VALVE INTO BRACKET FROM INSIDE, AND PUSH ALL THE WAY FORWARD (SEE ILLUSTRATION ABOVE).

- 4) THREAD RING NUT ONTO VALVE BODY, AS FAR IN AS POSSIBLE, TOWARD FRONT OF FOUNTAIN. **NOTE: IF REPLACING A 5871 OR 5872 SERIES VALVE, YOU MAY HAVE TO PLACE ADDITIONAL RING NUTS (TO BE USED AS SPACERS AND SUPPLIED W/5874PB) IN FRONT OF THE RING NUT (SEE ILLUSTRATION ABOVE), TO ALLOW NEW LONGER VALVE TO FIT IN A TIGHT LOCATION.**

- **7) THREAD PUSH BUTTON ASSEMBLY ON VALVE UNTIL WAVE WASHER MAKES SLIGHT CONTACT WITH STEM OF CARTRIDGE. **CAUTION: DO NOT HAND-TIGHTEN.**
 - 8) UNTHREAD RING NUT FORWARD UNTIL IT STOPS FLUSH WITH PUSH BUTTON ASSEMBLY.

- 9) PUSH VALVE BACK TOWARD THE INSIDE OF BRACKET AND TIGHTEN LOCKNUT (SEE ILLUSTRATION ABOVE).
 - 10) TIGHTEN PUSH BUTTON ASSEMBLY USING UNIVERSAL SPANNER WRENCH PROVIDED.

- ** OVERTIGHTENING WILL PRE-ACTUATE VALVE AND CAUSE WEEPAGE, WHILE NOT ENOUGH CONTACT BETWEEN WAVE WASHER AND STEM CAN CAUSE A LOW FLOW CONDITION.
