model 5874PB

Fountain Valve

INSTALLATION INSTRUCTIONS FOR 5874PBF.

INSTALLATION INSTRUCTIONS FOR 5874PB.

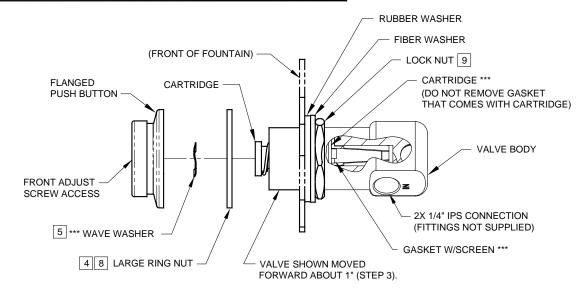
ASSEMBLED 5874PBF (FLUSH MOUNT APPLICATION)

*** MODEL VRK5874 & VRK5874HF- VALVE REPAIR KITS INCLUDE THESE ITEMS

- 1) FOLLOW INSTRUCTIONS CAREFULLY ON O&M MANUAL (PAGE 2 OF 6) WHEN REMOVING OLD VALVE. NOTE: SEE PARTS BREAKDOWN (PAGE 4 OF 6) FOR ADDITIONAL NOTES.
- 2) VERIFY THAT LOCK NUT, FIBER, AND RUBBER WASHERS ARE POSITIONED SLIGHTLY PAST MIDWAY OF THREADS ON NEW VALVE BODY.

- 3) INSERT VALVE INTO BRACKET FROM INSIDE AND PUSH FORWARD ABOUT 1".
- 4 THREAD LARGE RING NUT ONTO VALVE BODY, APPROXIMATELY 1" INTO VALVE.
- 5 PLACE WAVE WASHER INSIDE OF FLANGED PUSH BUTTON ASSEMBLY (MUST BE IN PLACE).

- 6 APPLY ONE (1) DOT OF LOCTITE 222MS, ON THE FEMALE THREADS OF BUTTON ASSEMBLY LEAVING THE FIRST AND LAST THREADS FREE. (FIGURE 1). CAUTION: EXCESS LOCTITE CAN CAUSE THREADS TO LOCK VERY TIGHTLY, MAKING REPAIRS DIFFICULT.

- **7) THREAD FLANGED PUSH BUTTON ASSEMBLY ON VALVE UNTIL WAVE WASHER MAKES SLIGHT CONTACT WITH STEM OF CARTRIDGE. CAUTION: DO NOT HAND-TIGHTEN.
- 8 UNTHREAD RING NUT FORWARD UNTIL IT STOPS FLUSH WITH PUSH BUTTON ASSEMBLY.

- 9 PUSH VALVE BACK TOWARD THE INSIDE OF BRACKET AND TIGHTEN LOCKNUT (SEE ILLUSTRATION ABOVE).
- 10) TIGHTEN PUSH BUTTON ASSEMBLY USING UNIVERSAL SPANNER WRENCH PROVIDED.

- ** OVERTIGHTENING WILL PRE-ACTUATE VALVE AND CAUSE WEEPAGE, WHILE NOT ENOUGH CONTACT BETWEEN WAVE WASHER AND STEM CAN CAUSE A LOW FLOW CONDITION.

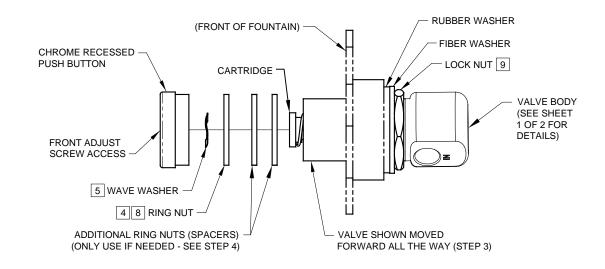
ASSEMBLED 5874PB (RECESSED MOUNT APPLICATION)

- 1) FOLLOW INSTRUCTIONS CAREFULLY ON O&M MANUAL (PAGE 2 OF 6) WHEN REMOVING OLD VALVE. NOTE: SEE PARTS BREAKDOWN (PAGE 4 OF 6) FOR ADDITIONAL NOTES.
- 2) VERIFY THAT LOCK NUT, FIBER WASHER, AND RUBBER WASHERS ARE POSITIONED TOWARD BOTTOM END OF THREADS ON NEW VALVE BODY.

- 3) INSERT VALVE INTO BRACKET FROM INSIDE, AND PUSH ALL THE WAY FORWARD (SEE ILLUSTRATION ABOVE).
- 4 THREAD RING NUT ONTO VALVE BODY, AS FAR IN AS POSSIBLE, TOWARD FRONT OF FOUNTAIN. NOTE: IF REPLACING A 5871 OR 5872 SERIES VALVE. YOU MAY HAVE TO PLACE ADDITIONAL RING NUTS (TO BE USED AS SPACERS AND SUPPLIED W/5874PB) IN FRONT OF THE RING NUT (SEE ILLUSTRATION ABOVE), TO ALLOW NEW LONGER VALVE TO FIT IN A TIGHT LOCATION.

- 5 PLACE WAVE WASHER INSIDE OF PUSH BUTTON ASSEMBLY (MUST BE IN PLACE).
- 6 APPLY ONE (1) DOT OF LOCTITE 222MS, ON THE FEMALE THREADS OF BUTTON ASSEMBLY LEAVING THE FIRST AND LAST THREADS FREE. (FIGURE 1). CAUTION: EXCESS LOCTITE CAN CAUSE THREADS TO LOCK VERY TIGHTLY, MAKING REPAIRS DIFFICULT.

- **7) THREAD PUSH BUTTON ASSEMBLY ON VALVE UNTIL WAVE WASHER MAKES SLIGHT CONTACT WITH STEM OF CARTRIDGE. CAUTION: DO NOT HAND-TIGHTEN.
- 8 UNTHREAD RING NUT FORWARD UNTIL IT STOPS FLUSH WITH PUSH BUTTON ASSEMBLY.

- 9 PUSH VALVE BACK TOWARD THE INSIDE OF BRACKET AND TIGHTEN LOCKNUT (SEE ILLUSTRATION ABOVE).
- 10) TIGHTEN PUSH BUTTON ASSEMBLY USING UNIVERSAL SPANNER WRENCH PROVIDED.

- ** OVERTIGHTENING WILL PRE-ACTUATE VALVE AND CAUSE WEEPAGE. WHILE NOT ENOUGH CONTACT BETWEEN WAVE WASHER AND STEM CAN CAUSE A LOW FLOW CONDITION.
